PHILOSOPHICAL TRANSACTIONS.

I. *On the great strength given to Ships of War by the application of Diagonal Braces.* By Robert Seppings, Esq. F. R. S.

Read November 27, 1817.

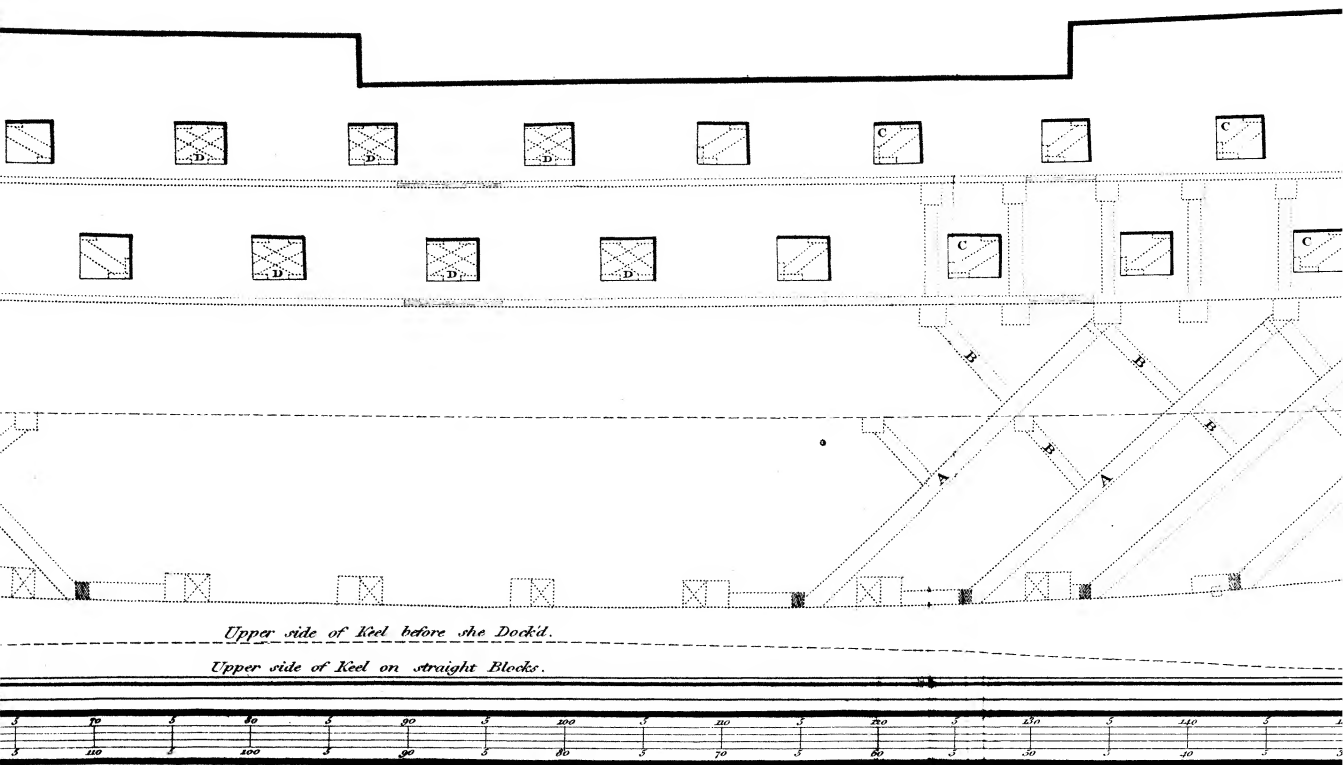
N^o 1.

blocks, how much she had altered from the state in which she was when afloat. They were then to place a certain number of trusses (conformably with the annexed drawing, Plate I. No. 1.) in the following manner: those in the hold marked A, to be placed in an angle of 45° , or thereabouts, and those marked B, at right angles to them; those in the ports marked C to be placed from the midships forward, in an angle of about 40° , and, from the midships aft, at the same angle, but in an opposite direction. As it was uncertain where the centre of fracture (or point of separation) would take place, a few of the port-holes about the centre of the ship were crossed, as shown in Plate I. at D. Wedges were applied to the heels of the trusses, which were then set tight. The ship being thus partially trussed, the water was then to be let into the dock, and the ship floated out of it into the bason, where she was to lay one hour, when a committee was to examine the sights, and ascertain how much the ship had altered; and again, what change had taken place in twenty-four hours after floating. This being done, the trusses were to be disengaged in as short a time as possible, in order to observe whether the effect of their removal would be instantaneous, or gradual.

“ When the ship was in dock, on blocks perfectly straight,
“ she came down in the midships, by the sights placed on
“ the gun-deck, two feet two inches and a half; and by
“ those on the upper deck, two feet three inches and a quar-
“ ter; and when undocked, with the trusses complete, and
“ in their places, she hogged, or broke her sheer, by the
“ sights on the gun-deck, one foot two inches; and by those

“ on the upper deck, one foot two inches and five eighths;
“ and at the expiration of twenty-four hours she had hogged
“ or further broke her sheer two inches and five-eighths,
“ and then appeared stationary, and completely borne by the
“ trusses.

“ We then proceeded to take away the trusses in the
“ hold, and when they were wholly disengaged, she further
“ hogged, or broke her sheer, six inches. We next pro-
“ ceeded to take away the trusses in the ports, and when
“ they were wholly cleared, she dropped at the extremities,
“ (or further hogged) three inches and a half, and was in
“ the same position when tried twenty-four hours after.

“ We further beg leave to state, that the whole of the
“ trusses marked B, slackened as the ship floated from the
“ blocks, and became short from half an inch to three inches
“ and a half, and partook of no part of the pressure; which in
“ our opinion clearly proves that the direction in which Mr.
“ SEPPINGS has applied his diagonal frame is correct, as also
“ the great utility of the trussing system; for although this
“ ship, from her very defective state, was much against so
“ severe an experiment, it has proved to us its good effects
“ most satisfactorily; for many of the trusses in the ports
“ forced *the timbers* three eighths of an inch within the ends
“ of their covering planks, thereby lessening their effect from
“ what it would have been if the ship had been of a sounder
“ texture; yet on a ship in this state, the trussing between
“ the ports alone, after those in the hold were wholly disen-
“ gaged, had the effect of sustaining the immense pressure

“ of both ends of the ship in her worst position, and pre-
“ vented her from breaking, which she otherwise would

“ have done, from three to four inches, and which she actually and *immediately* did on their being disengaged.”

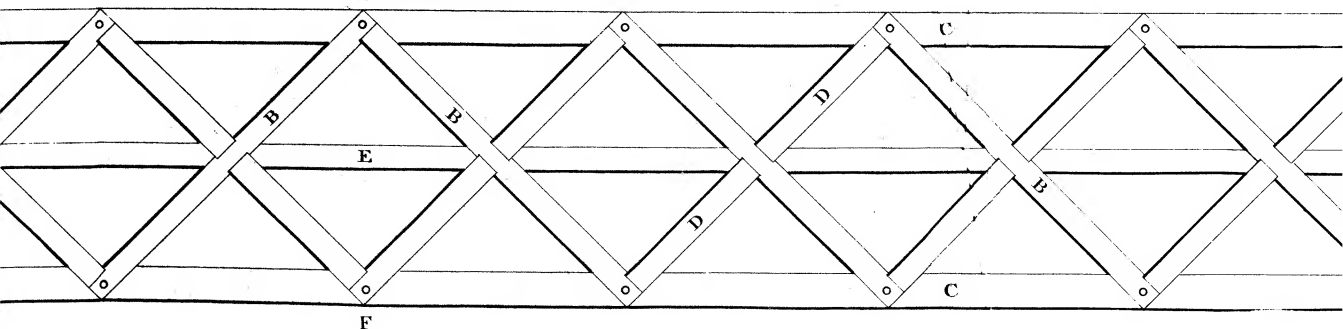
H N^o 2.

Let No. 2. Plate I. represent a frame of wood, having the braces B pinned to the upper and lower ties C; let the trusses D and the longitudinal pieces E, be merely let in without any fastenings; then make the point F the fulcrum, and pressing down the ends GG, it will be found that the frame comes more in contact by the pressure. Next reverse the frame, and let H become the fulcrum, and by pressing at I, I, it will be seen that the trusses D and the longitudinal pieces E will immediately be disengaged and fall out; this proves that, had the long braces in the ships built on this

system in the diagonal frame, been placed in the same direction that those in this experiment were that are marked A, the ships so constructed would, in the act of launching, pitching in a sea, and as they grew old, have slackened certain parts of the diagonal frame, and the fabric would have been supported by long *crooked trusses*, whose ends would have had but one point of support, namely, the shelf piece or internal hoop; and what is more objectionable, the ends of the trusses would, if so placed, have been cut off to an angle of 45° . On the contrary, by making the ties in the diagonal frame the abutments, as many additional points of support are gained, as the trusses B exceed the braces A; and further, the trusses B are now straight and short, and their ends are cut off to a right angle, and thereby give a support, and the longitudinal pieces a fixedness, which would not have been the case had they been laid in the other direction.
